# INCIDENT REPORTING SYSTEM MIAMI-DADE FIRE RESCUE

## FIRE INVESTIGATION REPORT

Incident Number: 3023903

395 NW 177 Street, Miami, FL 33169  
ADDRESS

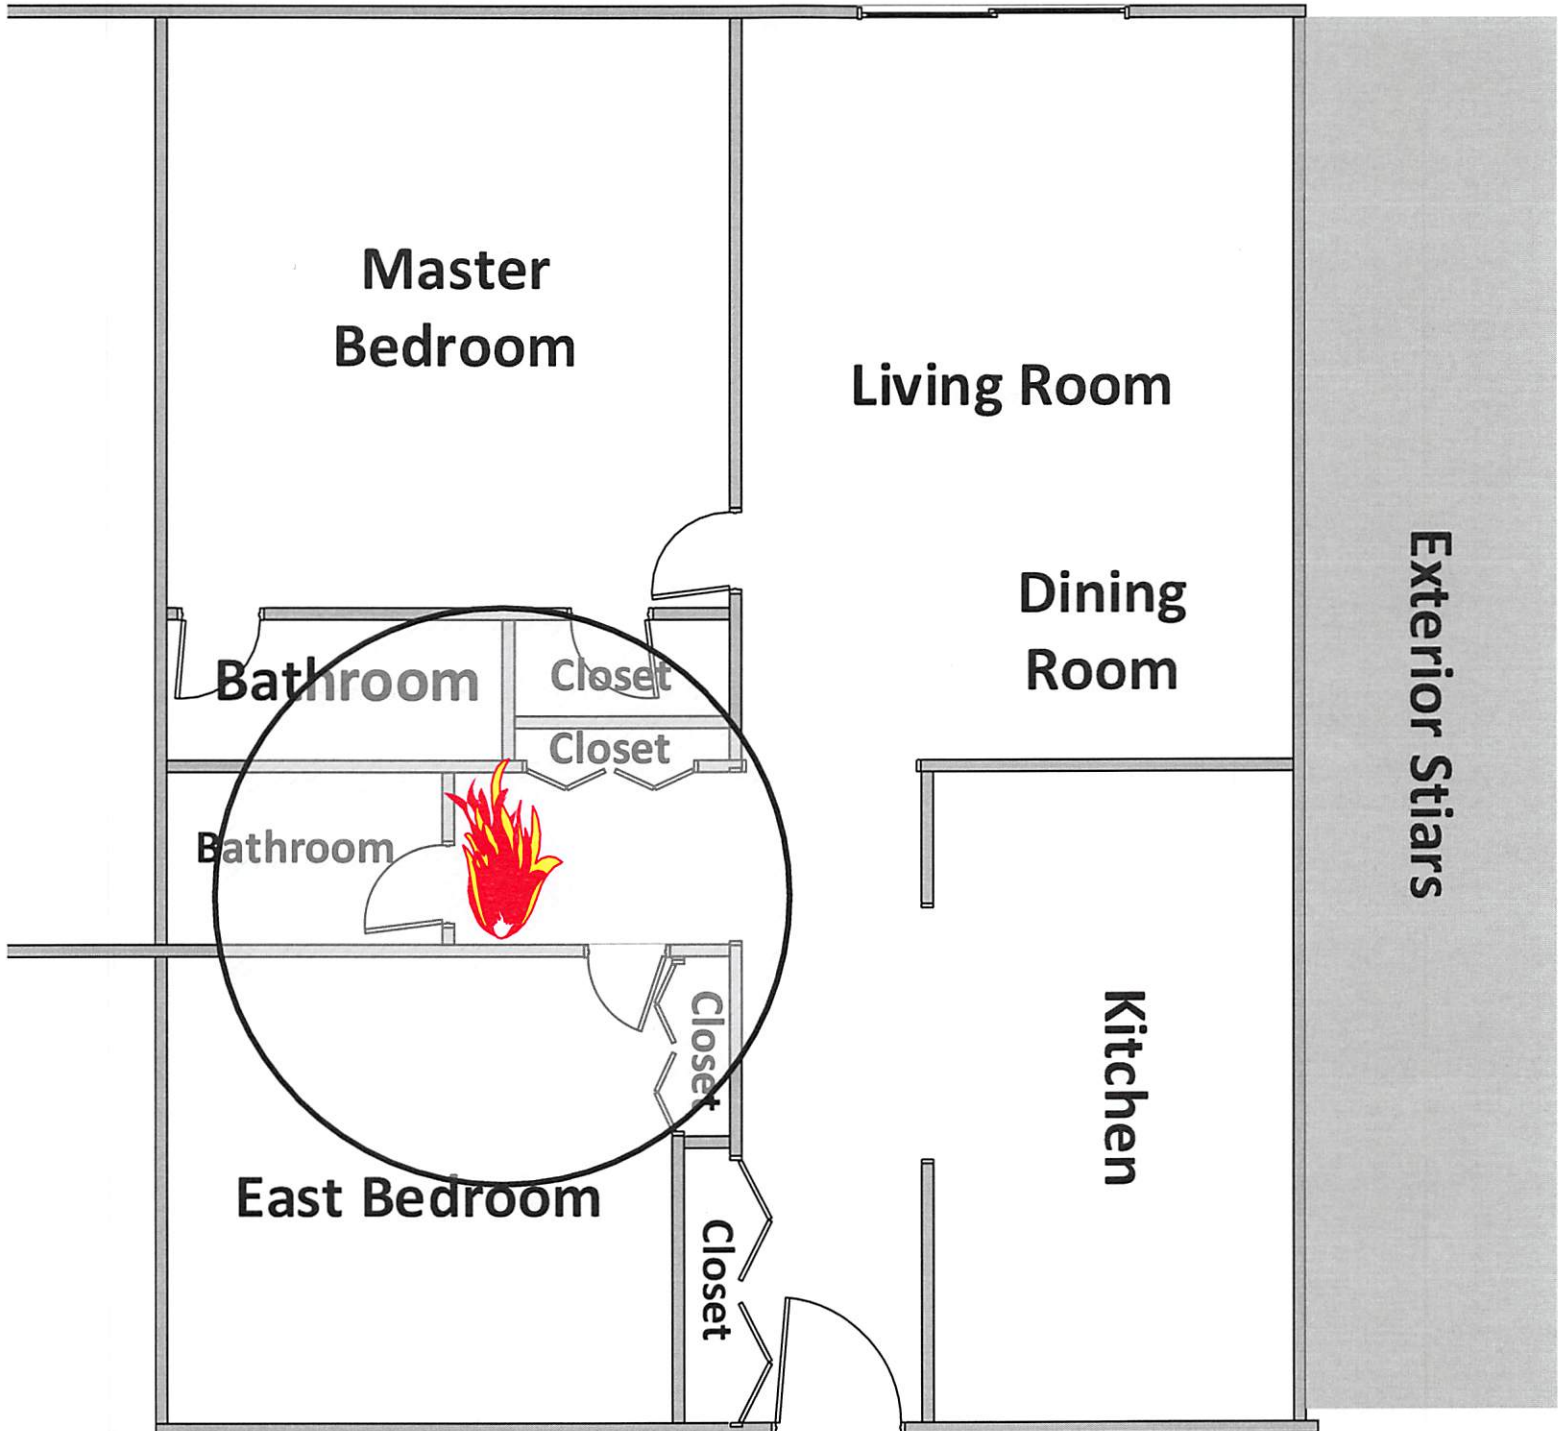
**Apartment 217**

193 After a complete and thorough examination of apartment 217, I was able to determine that the fire originated inside  
194 the cockloft space above this apartment. Examination of the existing wooden trusses showed the most significant  
195 mass loss on top of the bottom chords and the bottom of the top chords. These patterns were the same as seen  
196 above other areas that were known to have been involved in fire much later in the timeline. Identification of this area  
197 was made using eyewitness statements and video footage indicating that this area was the first to have visible smoke  
198 and fire.

Area of fire origin was determined to be inside the cockloft space above apartment 217. The depiction given here is an approximation as it relates to the apartments floor plan.

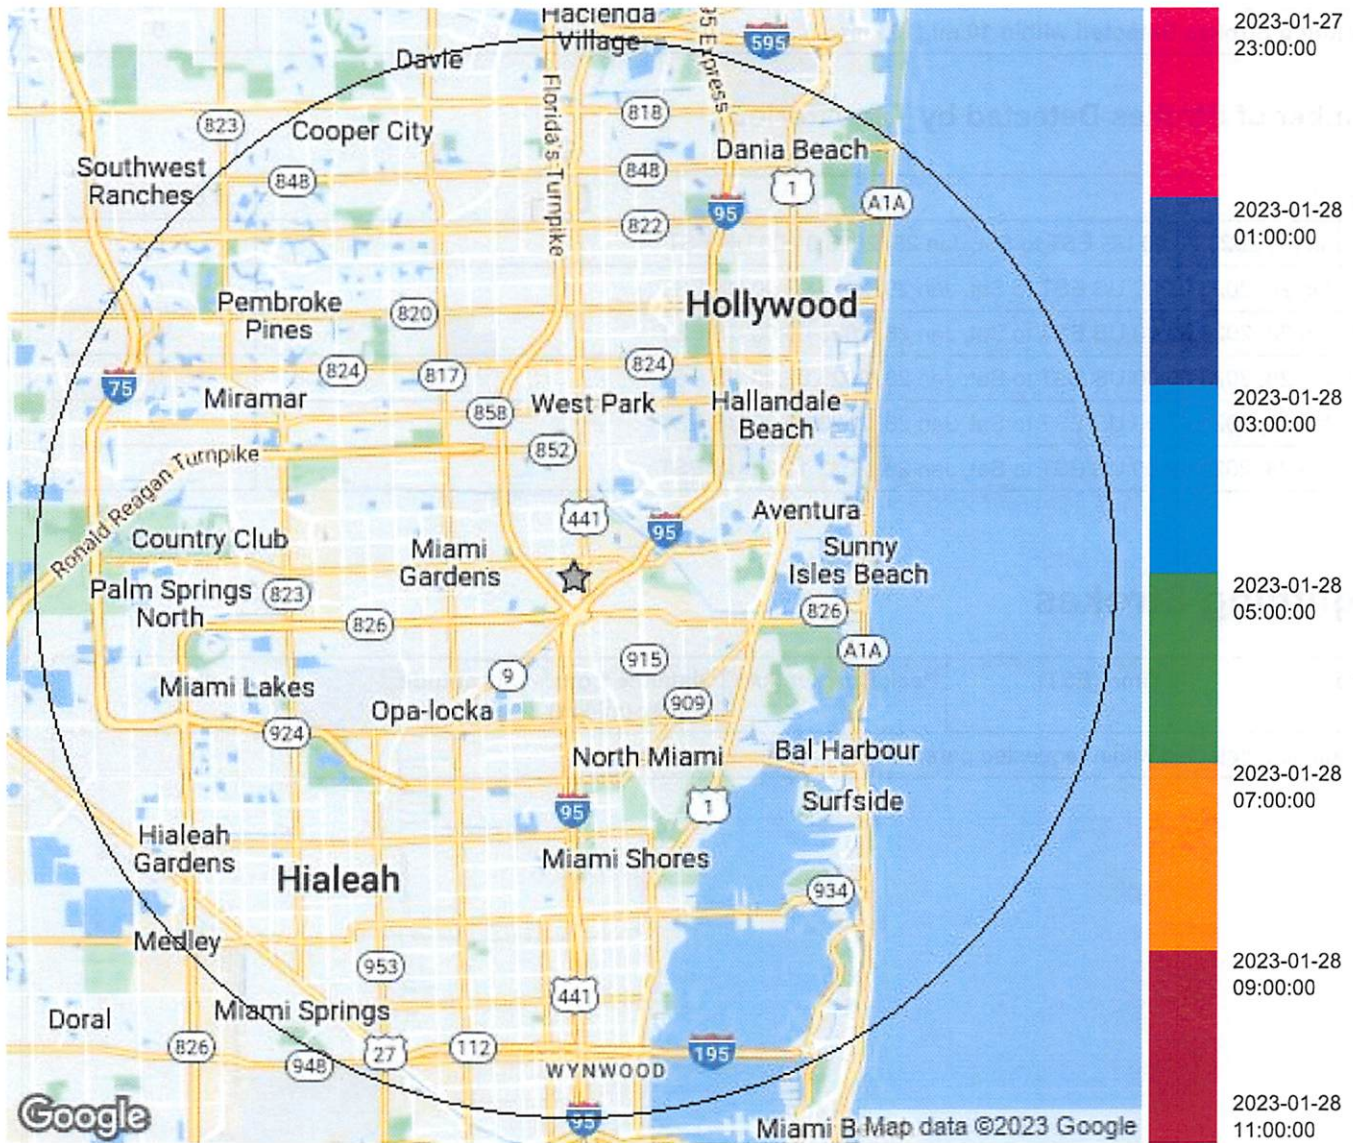
# Confidence Ellipses For Lightning Strokes

212 A report from Strikenet showed no lightning strikes within a ten-mile radius of the incident scene during the time  
213 period of 27JAN23 at 2300 until 28JAN23 at 1100.

STRIKENet verified there were ZERO cloud-to-ground lightning strokes detected within 10 miles of the property for the dates inquired.
